## **Community Service through Building Defect Inspection: Assessing Building Conditions of Orphanages in Cikarang, Indonesia**

This community service project was initiated by the Civil Engineering Study Program at President University. It aimed to inspect and analyze the physical condition of two orphanage buildings in Cikarang, West Java, namely Panti Asuhan Rumah Harapan Graha Asri and Panti Asuhan Rumah Singgah Anak Berkat. These buildings were selected due to their visible signs of deterioration and lack of maintenance. The problems identified ranged from aging materials, moisture damage, poor ventilation, unstable flooring, to structural cracks and mold infestation, issues that pose risks to both safety and health.

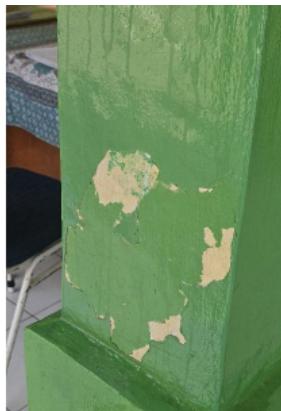
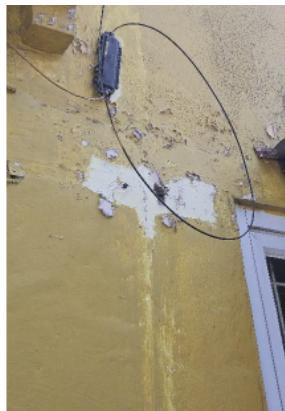
The building inspection at Rumah Harapan Graha Asri Orphanage revealed several visible signs of long-term deterioration, primarily due to moisture exposure and aging construction materials. One of the most prominent defects was peeling paint on exterior and interior wall surfaces, especially at the columns and corners (Figure 3). This damage suggests prolonged moisture intrusion, likely from roof leaks or water seepage through porous surfaces. In some areas, the paint layer had completely detached, exposing raw concrete or plaster underneath.

**Figure 3.** Peeling paints indoor and outdoor

1. Repair and Waterproofing: Damaged surfaces, particularly areas affected by water penetration, should be stripped and refinished with water-resistant coatings. Leaks around roof-wall intersections should be sealed using appropriate flashing or waterproofing membranes.

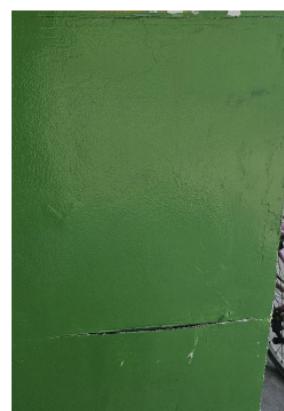
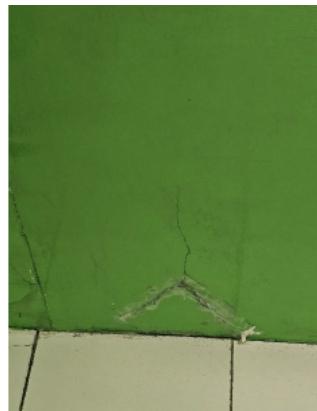
Structural cracks were also observed, particularly at the base of several columns (Figure 4). These horizontal cracks may indicate differential settlement, a condition where the foundation shifts unevenly over time, or stress due to thermal expansion and contraction. Diagonal cracks were found at the junction between the wall and floor elements, indicating a shift or difference in deformation between the two planes. The exact cause could not be confirmed without structural testing, but the cracks represent a potential hazard if left unmonitored.

**Figure 4.** Structural cracks

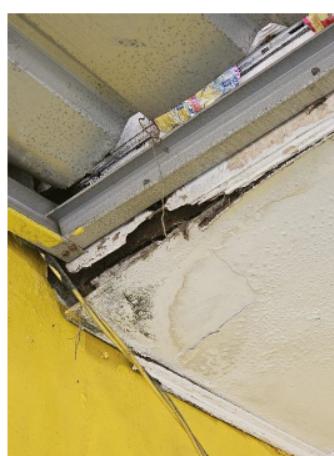
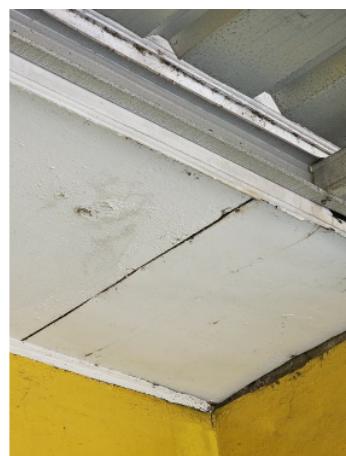
In addition, the team identified roof-to-wall joint problems, including gaps, discoloration, and signs of previous water leakage (Figure 5). These defects contribute to internal dampness and could worsen during the rainy season. The combination of environmental exposure, inconsistent repairs, and insufficient waterproofing has contributed to a decline in the building's physical condition, warranting immediate preventive action.

**Figure 5.** Roof-to-wall joint problems

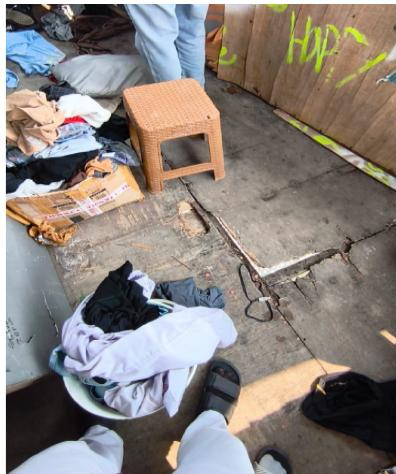
constructed almost entirely from aged plywood and untreated wood framing, materials that showed signs of warping, delamination, and structural fatigue (Figure 6). The students noted that the plywood flooring was unstable and could collapse under concentrated loads.

**Figure 6.** Second floor of Rumah Singgah Anak Berkat

2. Structural Reinforcement: Weak or unstable elements, such as plywood flooring and wooden stairs, should be replaced with more durable materials like engineered wood, light steel, or reinforced concrete, depending on availability and budget.

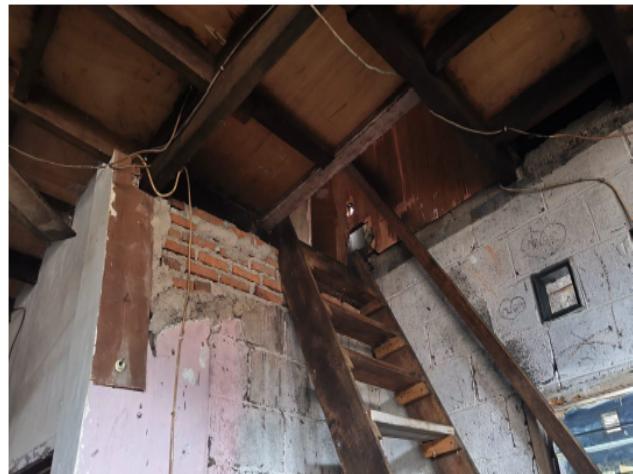
The wooden staircase providing access to the second floor also raised safety concerns (Figure 7). It exhibited visible bending, loose connections, and creaking underweight, suggesting it may no longer meet basic load-bearing requirements. In a facility housing children, this represents a serious risk that should be urgently addressed.

**Figure 7.** Wooden staircase

4. Safety Improvements: Staircases, ceilings, and floors should be upgraded to meet basic safety standards. This includes securing stair handrails, installing solid flooring, and providing a proper ceiling to reduce heat transfer and dust accumulation.

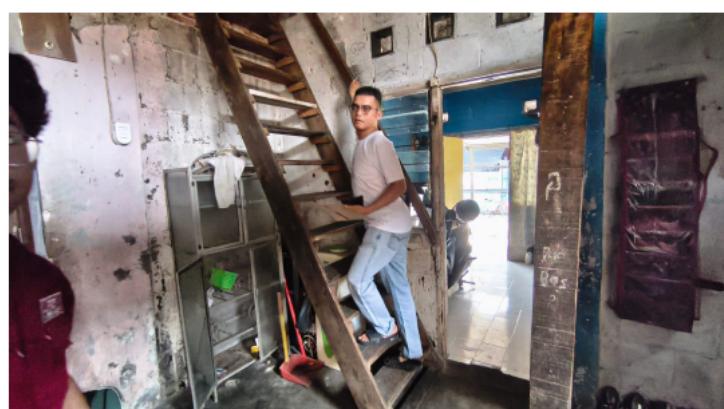
Another significant issue was the presence of black mold (likely *Stachybotrys chartarum*) on various wall surfaces, particularly in damp areas with poor ventilation (Figure 8). This mold not only damages the building fabric but also poses health risks, including respiratory problems, especially for children with allergies or asthma.

**Figure 8.** Black molds on walls (Source: Authors' documentation)

3. Mold Remediation: Affected interior walls must be cleaned using mold-killing solutions and repainted with fungal-resistant paint. Improving ventilation is also essential to reduce future mold growth.

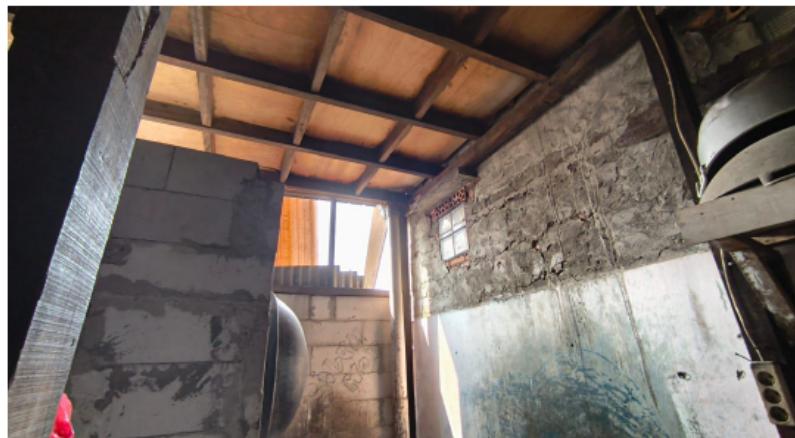
Externally, the unfinished masonry walls made of white stone were observed to be unpainted and unsealed (Figure 9). These porous surfaces readily absorb water, accelerating material degradation and potentially allowing further moisture ingress into the interior walls. Collectively, these issues indicate that the building is in a highly vulnerable condition, particularly during the rainy season or in humid weather.

**Figure 9.** Unfinished walls (Source: Authors' documentation)
